## AIRCRAFT ACCIDENT REPORT

OPNAV REPORT 3750-1

PART V. THE ACCIDENT

SNJ 20-253, BuNo 112278 departed N.S. CORRY FIELD at approximately 1010 CST, on Tuesday, 23 April 1957. The flight was a precision two (2) solo training syllabus flight. The pilot was NavCad George Windsor CHIHULY. Following take-off and climbout, the student pilot intended to perform regular syllabus maneuvers which included wing-overs and Chandelles for high work, and several touch and go landings at OLF, Choctaw. It is assumed that regular syllabus maneuvers were practiced until the aircraft entered a spin and spun to the earth, crashed and burned.

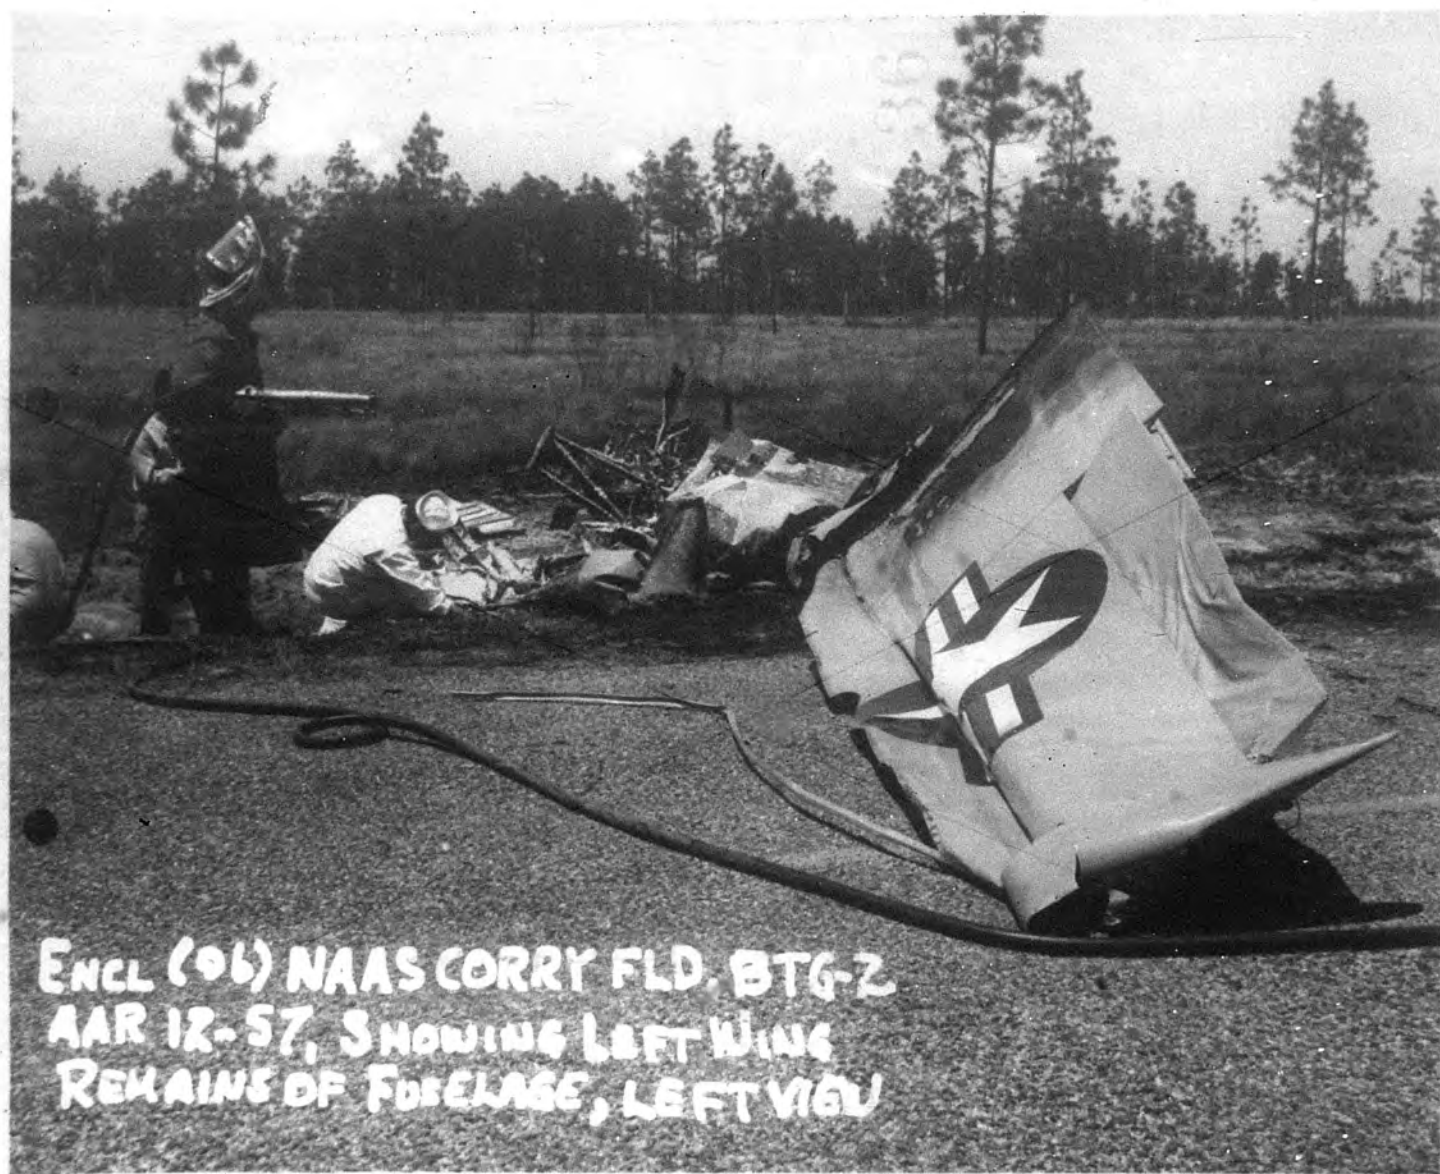
ENCL (96) NAAS CORRY FLD. BTG-Z  
AAR 12-57, SHOWING LEFT WING  
REMAINS OF FUSELAGE, LEFT VIEW

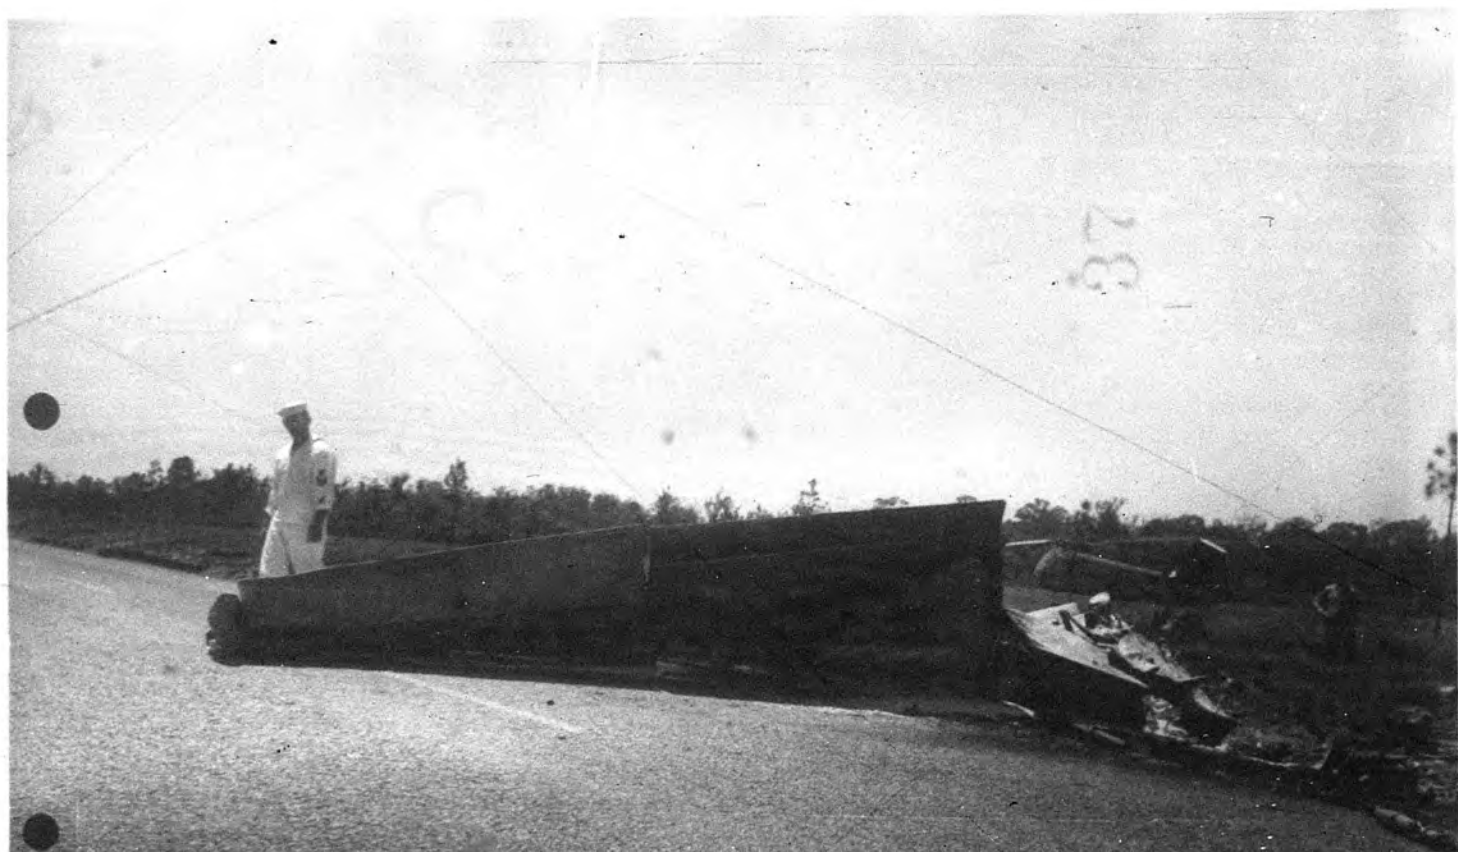
ENCL (9e) NAAS CORRY FLD, BTG-2, AAR 12-57  
SHOWING LEFT REAR VIEW. SIDE NO. OF ACFT.  
WAS 2C-253. MARKINGS SHOWN THIS VIEW WAS  
THE ONLY CLUE TO SIDE NUMBER.

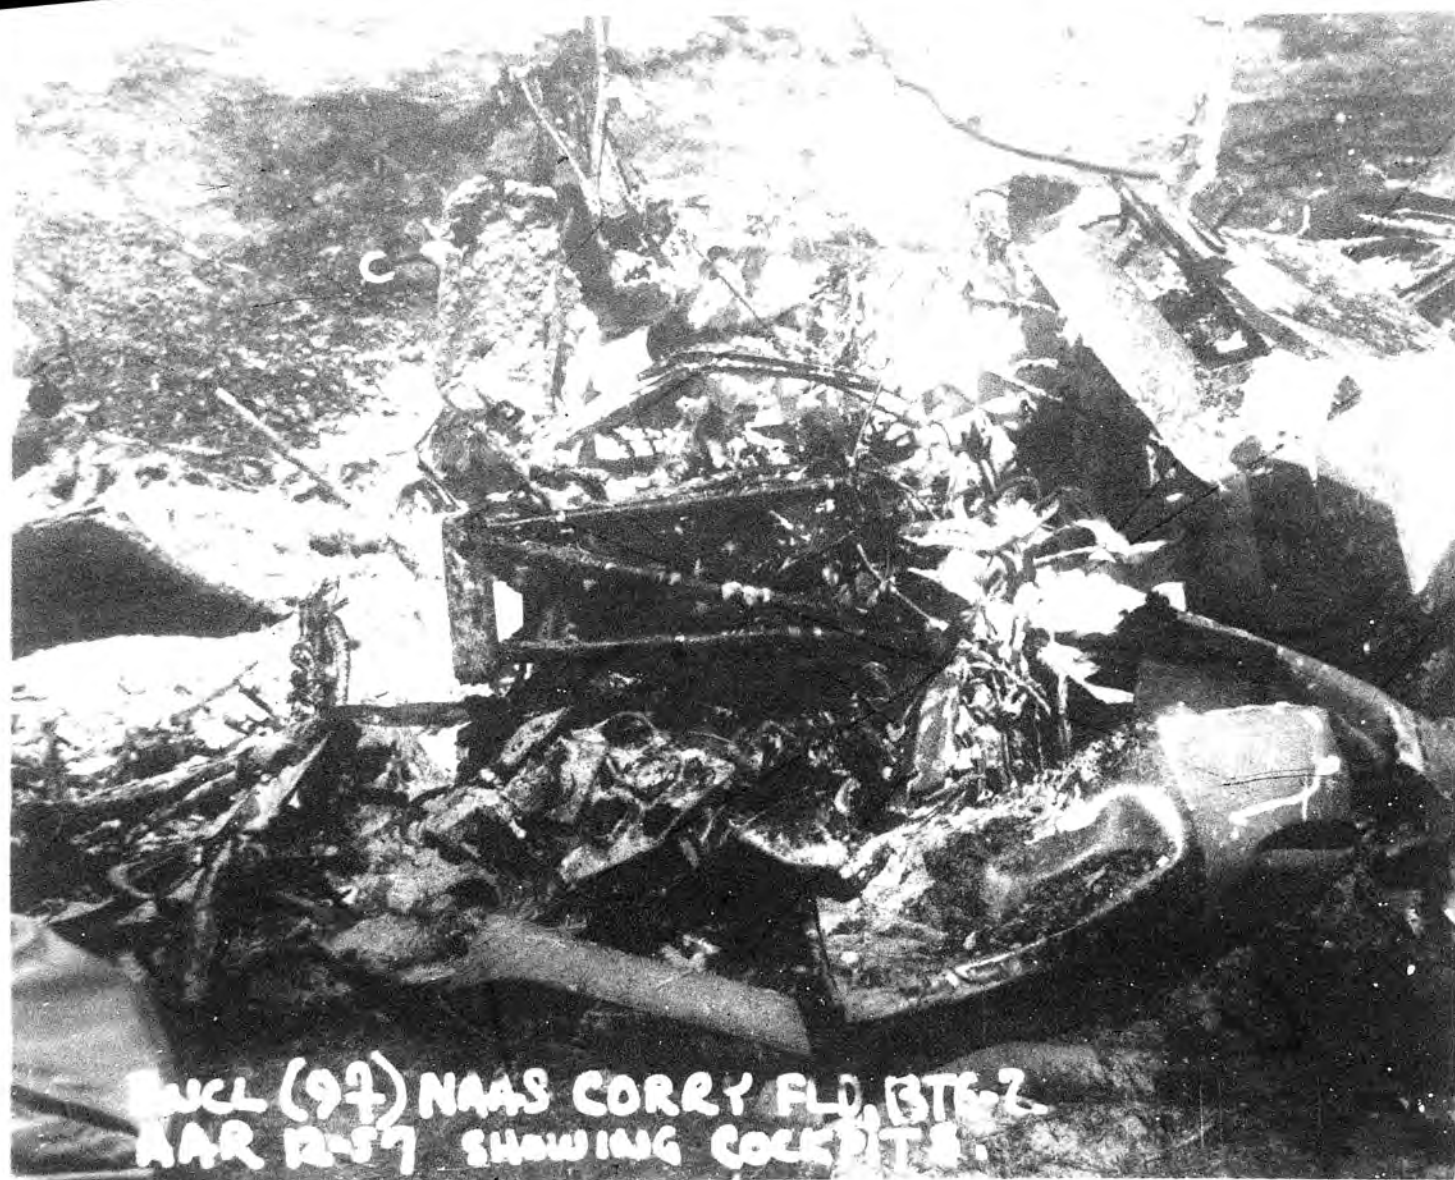
BUCL (97) NAAS CORRY FLD, IRE-2  
MAR 12-57 SHOWING COCKPIT.

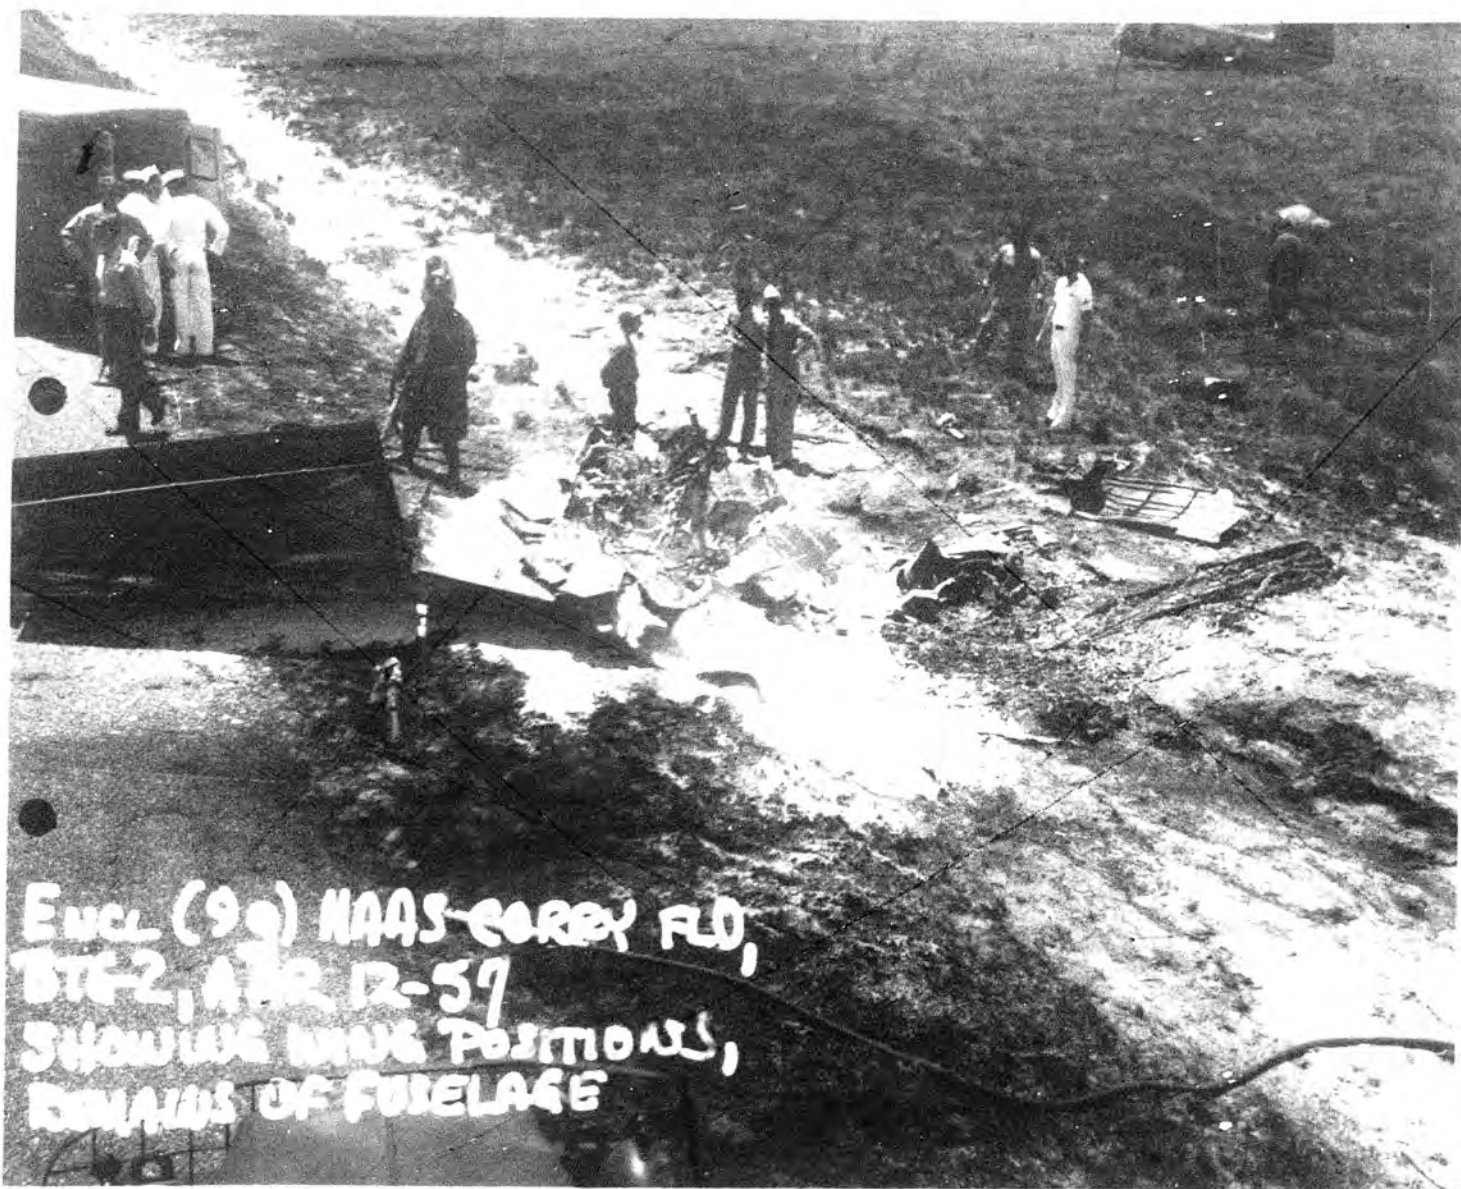
ENCL (9g) NAAS-COREY FLD,  
BTE-2, APR 12-59  
SHOWING WING POSITIONS,  
REMAINS OF FUSELAGE
